## Crankshaft Position Sensor Connection

| Models Covered | Serial Number |
|---|---|
| MCM 5.0L, 5.7L (350 MAG), and 6.2L (377 MAG) DTS ECT engines (including Axis) | 1A300000–1A653330 |
| MIE 5.7L and 6.2L DTS ECT engines | 1A090000–1A092904 |

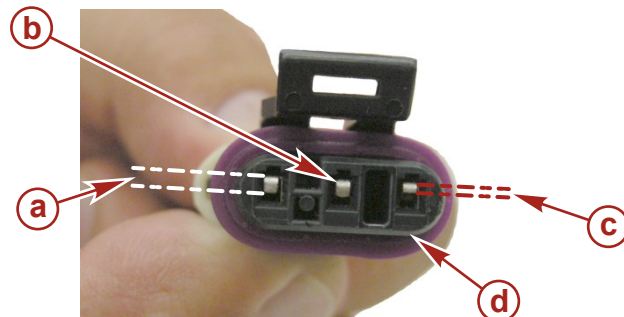
### Comparing terminal ends

3. Inspect the three female terminals in the sockets of the engine wiring harness connector.
  - a. Turn the harness connector so you can see the mating end of the connector body.
  - b. Note the size of the female terminal ends visible in the opening of the connector's sockets—A, B, and C. The female terminal ends must nearly fill the socket opening and be the same size. Compare the properly formed (wide) female terminal ends (sockets A and B) with an improperly formed (narrow) terminal end socket C).

- a** - Properly formed (wide) terminal end—socket A
- b** - Properly formed (wide) terminal end—socket B
- c** - Improperly formed (narrow) terminal end—socket C
- d** - Harness connector

4. If one or more of the female terminals in the sockets appears smaller, disassemble and repair (bend) the terminal, or terminals, back into their correct shape or replace the connector using the CPS replacement connector and wire kit.
