## Crankshaft Position Sensor Connection

| Models Covered | Serial Number |
|---|---|
| MCM 5.0L, 5.7L (350 MAG), and 6.2L (377 MAG) DTS ECT engines (including Axis) | 1A300000–1A653330 |
| MIE 5.7L and 6.2L DTS ECT engines | 1A090000–1A092904 |

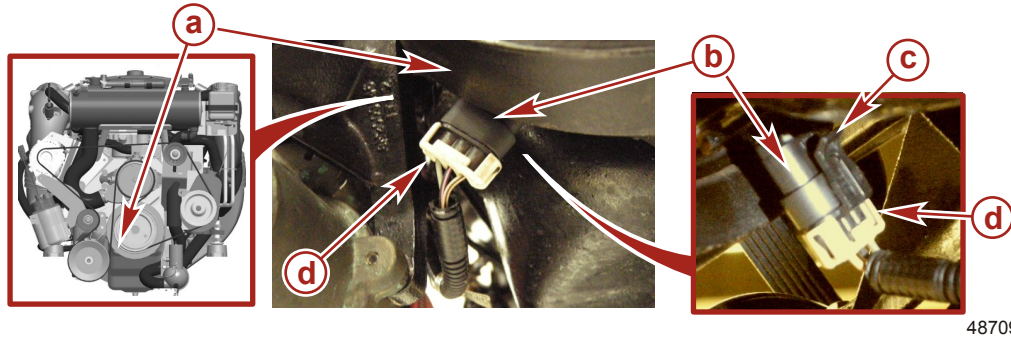
- a** - Harness connector
- b** - Torsional damper
- c** - CPS receptacle
- d** - Lock tab

2. Disconnect the engine wiring harness connector from the crankshaft position sensor (CPS) receptacle near the torsional damper.
